Suggestion of Maintenance for Safety and Relief For the safe use of Sekigahara Product

Accident
Record

Corrosion of Brake Drum Flange for Boat Winch

SHS-33-056 SHS-35-054 SHS-35-062 SHS-37-054
SHS-37-058 SHS-37-062 SHS-38-079

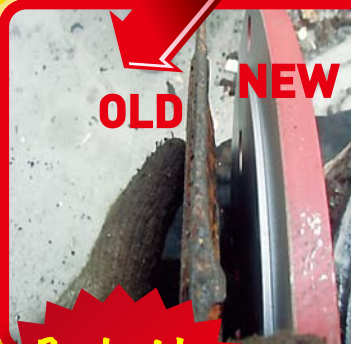
During the annual inspection, it is found out that drum flange for centrifugal brake case was badly corroded and flange became very thin. It is also found that screws were corroded and there was some gap between the flange and the brake case. It seems that water went inside of brake case and brake lining was broken and brake itself was corroded.

OLD **NEW**
Back side flange corroded to be thinner

Regular maintenance to avoid the rust is necessary.

Removal of rust and touch up painting.

Replacement of rusted / corroded parts.

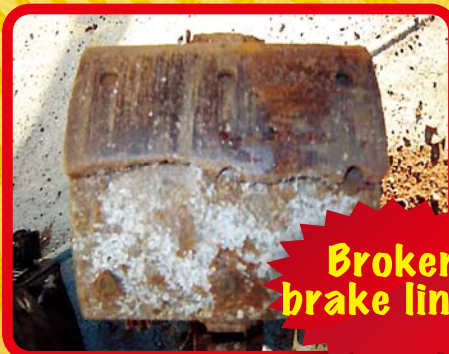
Broken brake lining

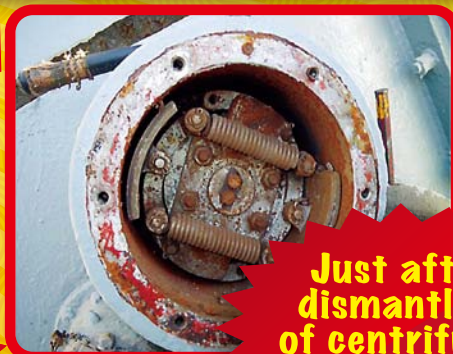
Just after dismantling of centrifugal brake case

When the water splashed on the winch, it made the installation screws corroded and they lost screw heads. This made the gap and flange became corroded due to intruded salt water. Then, the rust swelled and the gap got bigger. The brake case was not vertically installed any more. As a result, salt water entered inside and brake was corroded.

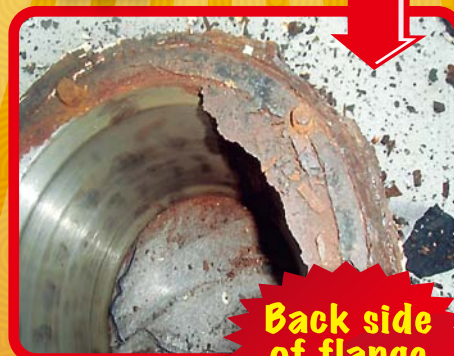
Note: Bottom side of flange need to be checked very carefully. This is when the corrosion is normally remarkably bad.

Back side of flange

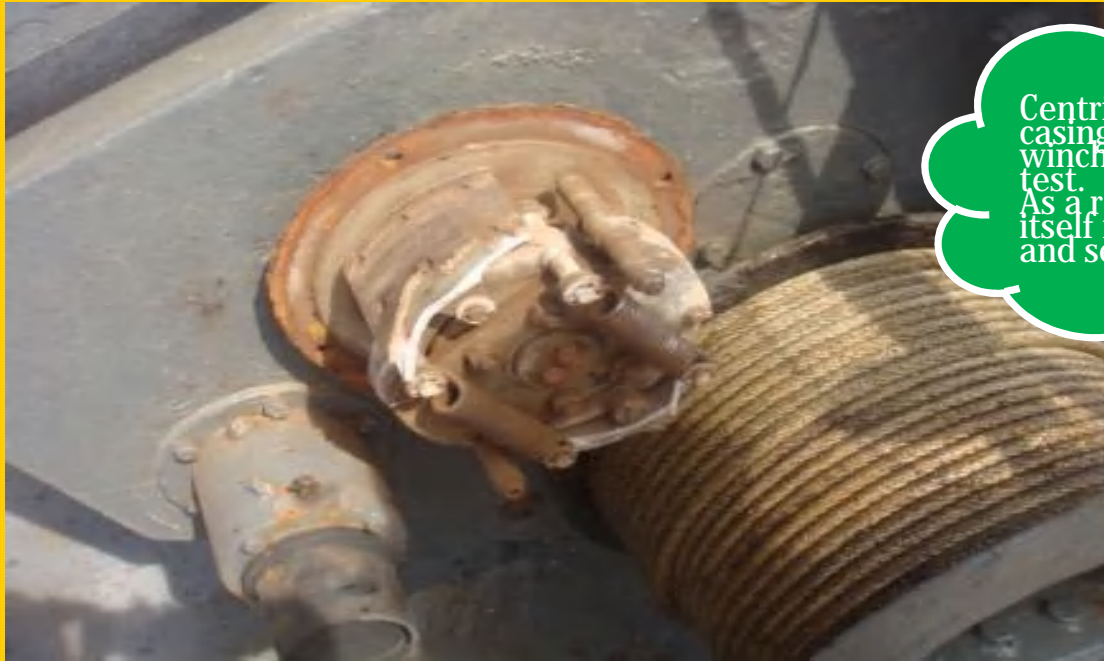
Here is one of the most critical cases. Crews will never be able to lower the davit safely. Not being able to evacuate from the vessel at emergency!!

A davit manufactured in 1998.

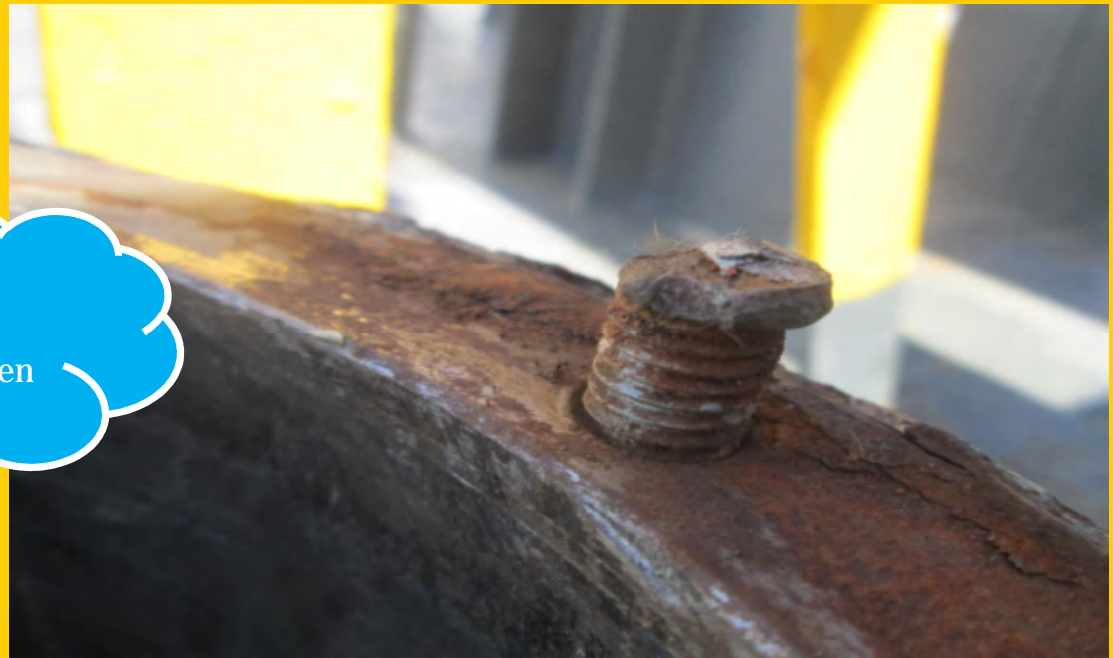
Centrifugal brake casing fell off from the winch during launching test. As a result, the brake itself is exposed to rain and sea breeze.

This was caused by the extremely bad corrosion. Screw head is broken and missing.

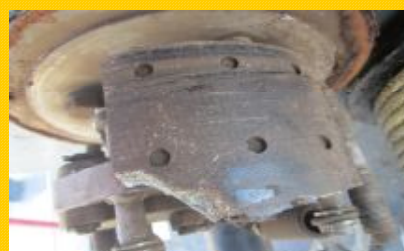
One corner of brake lining is broken and missing.
