Service News

Suggestion of Maintenance
for Safety and Relief
For the safe use of Sekigahara Product

SSN-003

Is the CAM CLUTCH on your vessel ready for safe use?

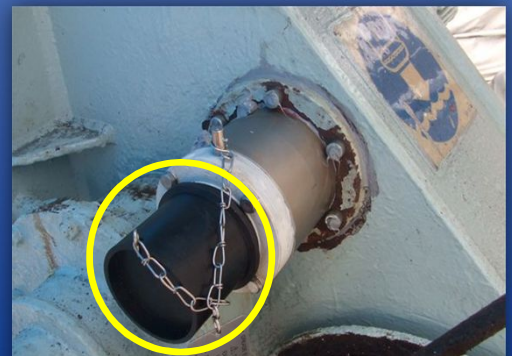
Rubber cap installed on cam clutch.

- ✂ We recommend to protect CAM CLUTCH from dust or sea water and other things by installing the rubber cap for above mentioned models.
- ✂ We consider that the replacing interval is 5 years for CAM CLUTCH. Please replace if it has been installed for more than 5 years.
- ⊘ Never put or spray water directly to this section.
- ⊘ Never dismantle and overhaul the CAM CLUTCH.

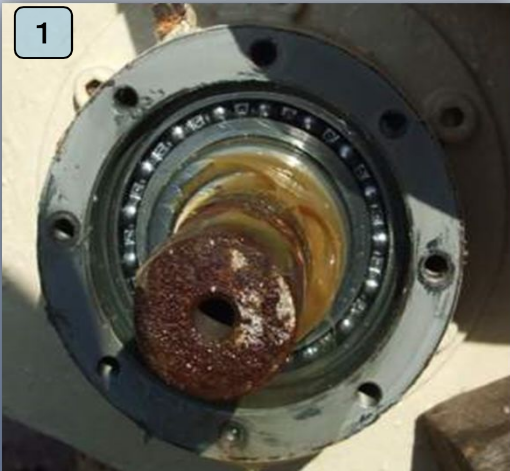
<Normal condition>

- 1) There is no rust on the surface of the bearing.
- 2) There is no dirt in the oil in the cam clutch.
- 3) There is no intrusion of grease.
(Oil bath type)

Judgement: Good condition

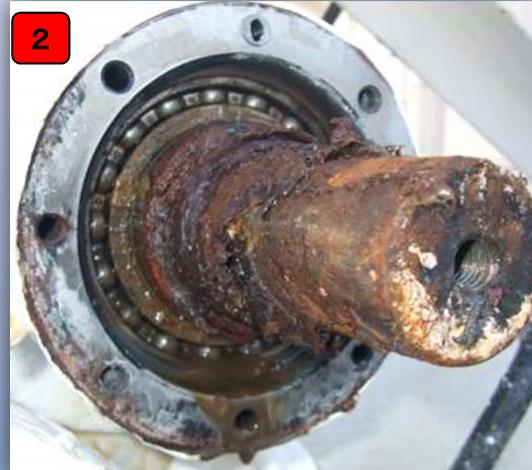
<Limit of use>

- 1) The surface of the bearing rusted.
- 2) Oil in the cam clutch is dirty

Judgement: Need to be replaced a.s.a.p.

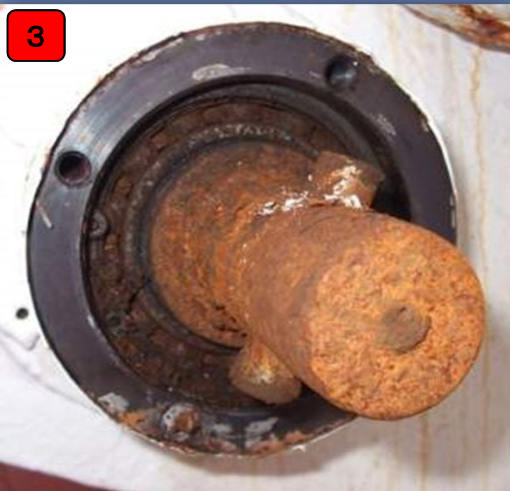
<Impossible to use>

- 1) The surface of the bearing rusted remarkably.
- 2) Oil in the cam clutch is empty.

Judgement: Do not use

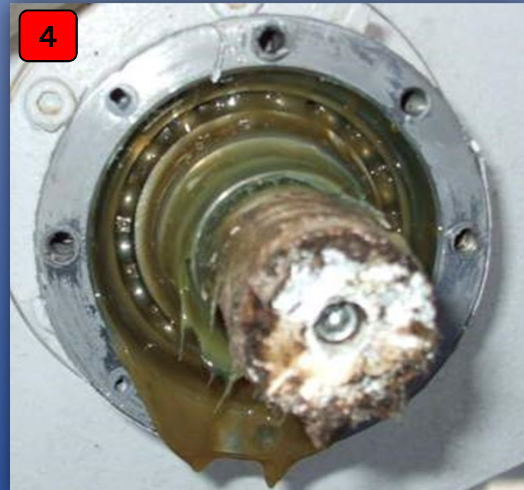
<Maintenance is necessary>

- 1) There is no rust on the surface of the bearing.
- 2) A large amount of grease is entering into the clutch.

(Treatment)

Clean with cleaning oil to remove grease in the clutch.
