# Service News

SSN-004

## Suggestion of Maintenance for Safety and Relief For the safe use of Sekigahara Product

### Malfunction of Travelling Movement

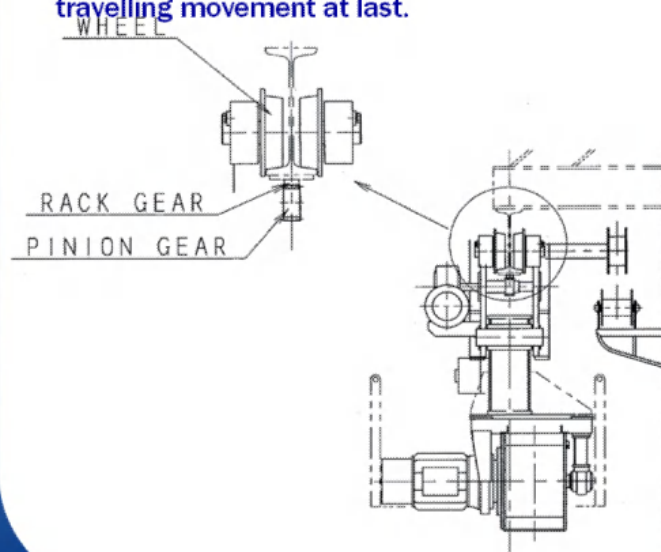
There is a section where the travelling device cannot move partly because the rack gear on rail and pinion gear on travelling device do not bite each other.

Pinion gear, rack gear, wheels and rail will wear little by little depending on how frequently the crane is used.

Whichever these are worn out, bite of the gears become less and less little by little. Then the top of gear teeth will be deformed and the section with frequently travelling and the most worn out section will have a problem on travelling movement at last.

Replace the pinion gear and rack gear where the worn out happened. If the replacing work is not possible, replace the pinion gear at least. In case the bite of pinion gear and rack gear is only a little, replace the wheels. If there is no development for the situation, replace the rail.

Do not carry out the up-sizing of pinion gear / wheels and thickening of rail because this may change the gear pitch. The travelling device may not be able to travel due to limiting system or the deformation of the crane parts caused by the too much pressure from biting gears.

Carry out regular greasing for slower the wearing of the gears.

Measure the wearing of the gear and the amount of gear bite once in 10 years and replace gears if necessary. The bite should be more than half of tooth height and the gear need to be replaced when the gear tooth became sharp.

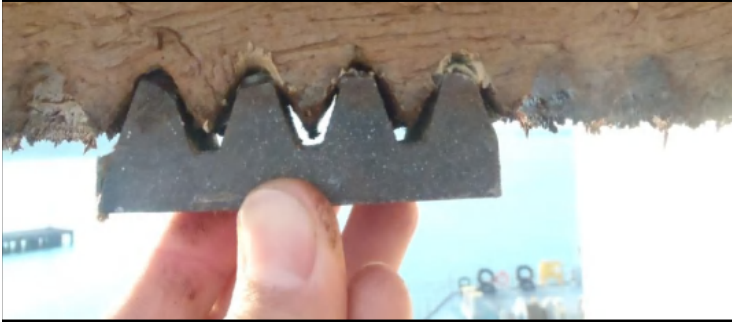
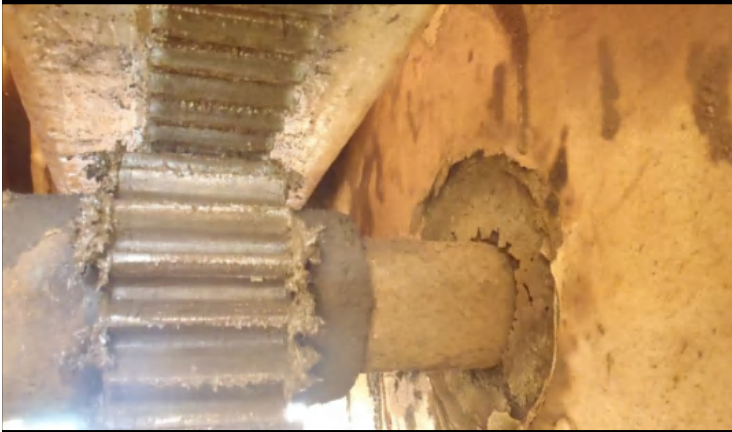
RGE-7/4 Manufactured in 2001 (Photo taken in 2011)

The rack deterioration by corrosion and aging degradation

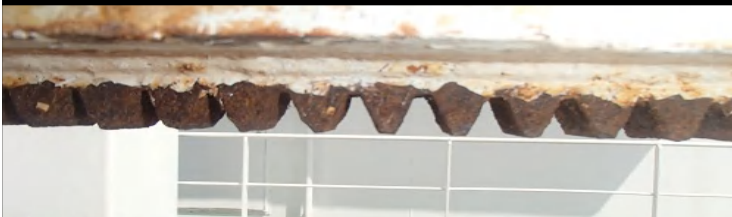
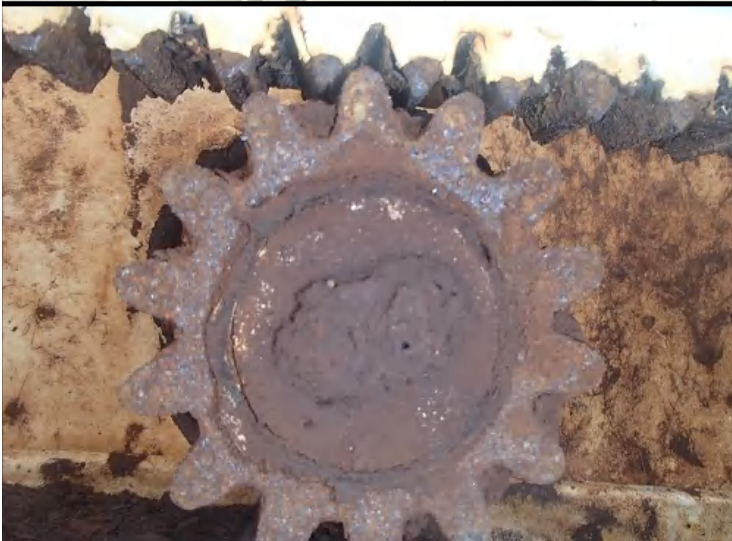
RGE-7/4 Manufactured in 2001 (Photo taken in 2014)

Pinion makes only small contact with the Rack  
by corrosion caused by rust
