Suggestion of Maintenance for Safety and Relief For the safe use of Sekigahara Product

[SUBJECT] Preventing the Deformation of Brake Arm

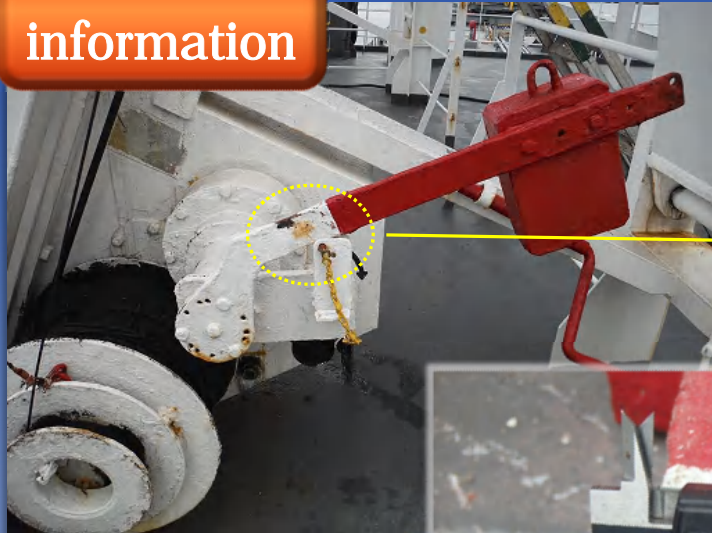
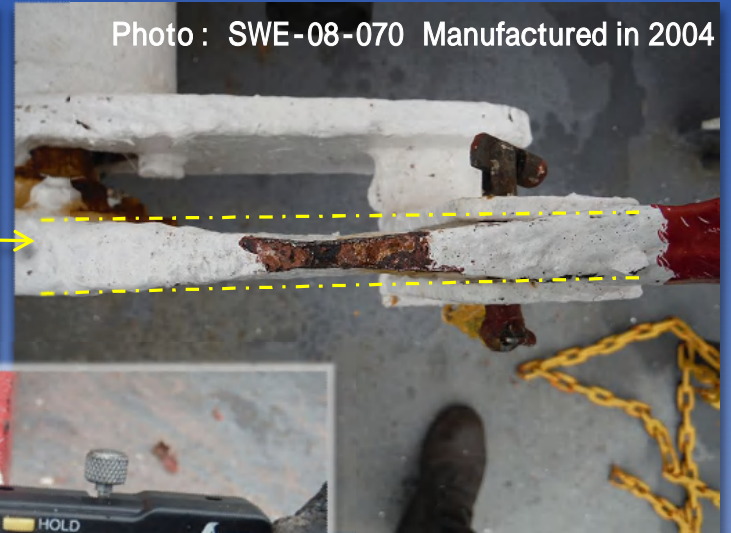
Photo : SWE-08-070 Manufactured in 2004

The brake arm (brake lever) may bend due to the unstable weight balance when the brake arm is lifted (at normal launching operation or hoisting operation by winch).

In case the arm is bent, it may be stuck to the lever guide and would not go back to suitable position for braking.

In case the rust is found, remove it and carry out touch up painting.

If the arm is worn out and becomes thin, repair work is necessary. Do not thicken the lever which may interfere with the lever guide.

If the thickness of the arm become less than 70% (8.4mm), urgent replacement of the lever is mandatory.

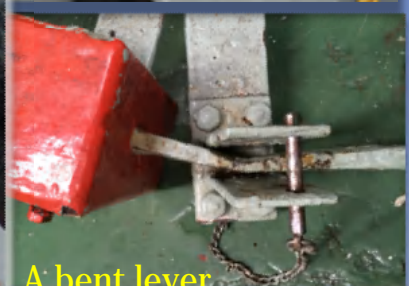
Lever is interfering with the guide because reinforcing material is too thick.
