Service News

SSN-012

Mysterious Operational Failure

Engine Room Crane
MSA-, MSB-, MAA-, MAB-,
MBA-, MBB-, ML-

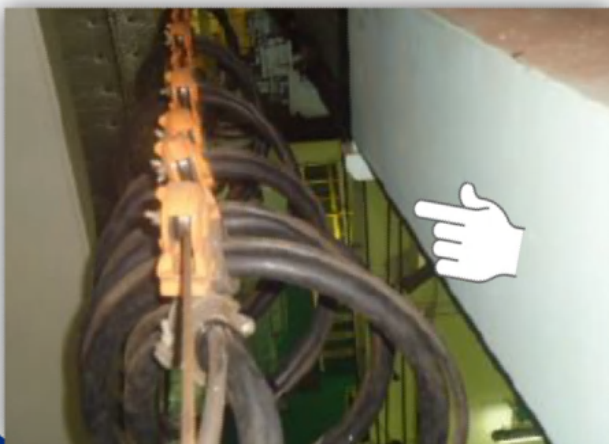
Accident
Record

During moving the hoist towards the center, it stopped all of sudden. Hook lowering operation also became impossible. If the hoist is moved to the wall side, it is operatable with normal condition. There are no special defect found on power source, motor, brake, limit device or pendant switch box.

Normal condition only in this area

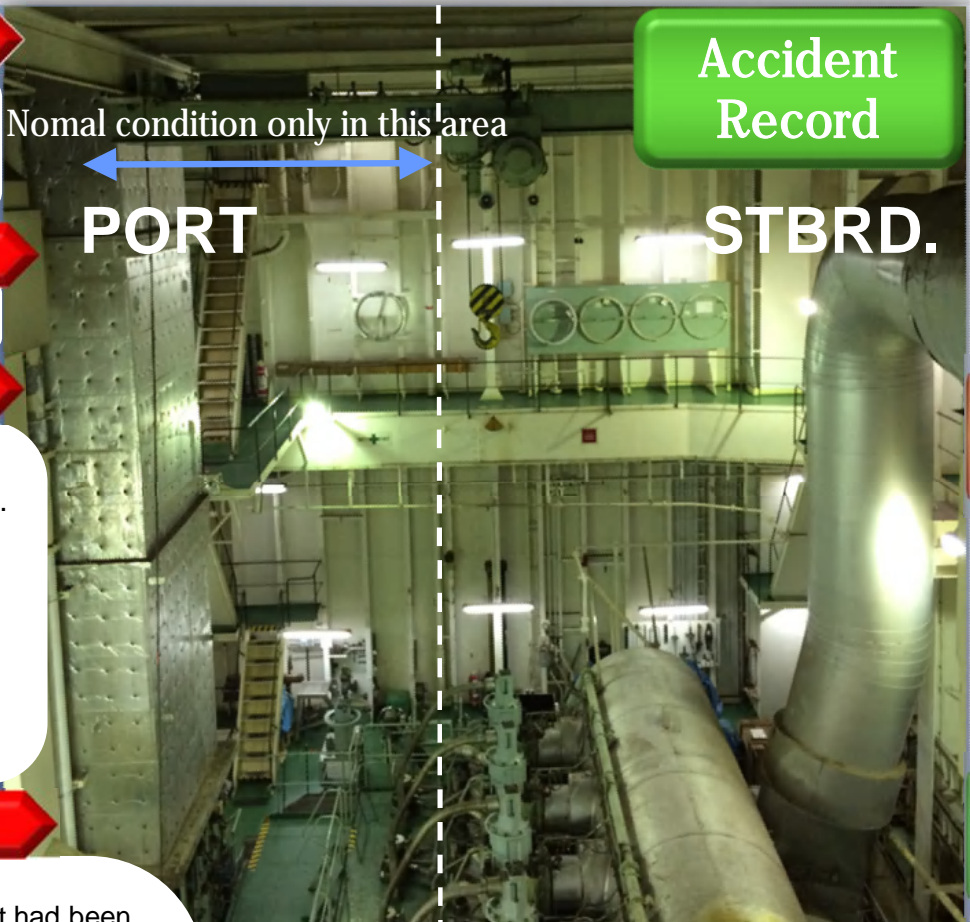
The power supply cable to the hoist had been used for a long time and it was stretched and bent repeatedly. As a result, wire inside of the cable was cut and disconnected. When the cable is stretched, disconnected wire was separated and the malfunction movement was observed due to the missing power & signal. When the cable was bent, inside wire was connected and no malfunction happened.

Since the disconnection of the cable cannot be checked from the outside of the cable, it is recommended to inspect or renew the cable regularly. In case the cable has not been changed for more than 8 years, you need to pay special attention to it.

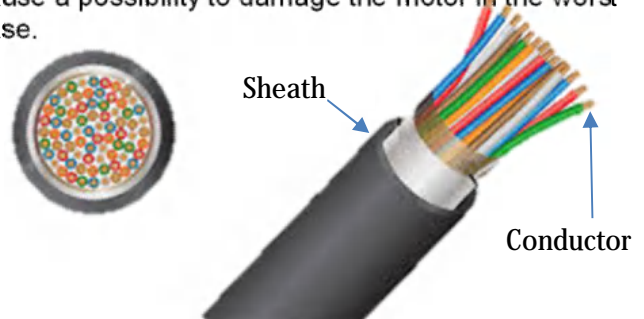
Cabtyre cable is a cable which supplies the power source (power / signal) to the hoisting device. Inside of the sheath, there are some conductors. Even the conductor for the brake is disconnected only, the motor is trying to move with brake working and this cause a possibility to damage the motor in the worst case.
