All the hinged type (SHS model)

3. Outline

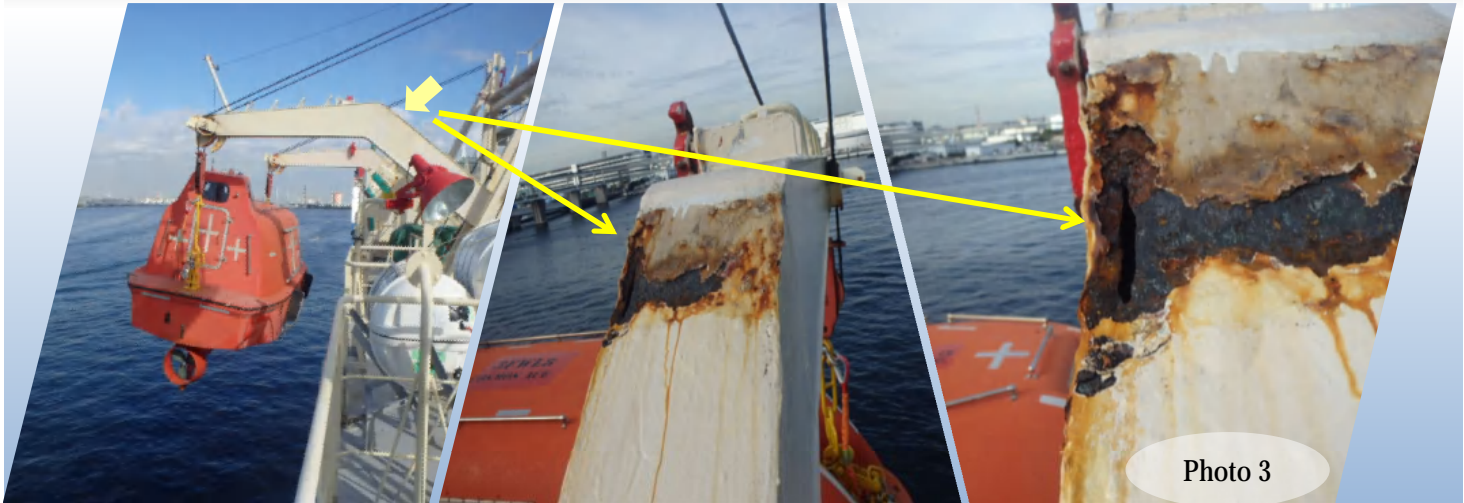
Remarkable corrosion was confirmed at the back and upper side of the cradle (davitt arm) and there was a hole. [Photo 3] If no measurement was taken on this condition, rain or sea water would go inside of the cradle from this hole and the corrosion would progress. This may lead to the weakening of the strength of the cradle itself.

During davitt recovering procedure by manual hand brake, the cradle was hoisted fully and tension of the fall wire was not released. At this point the cradle and the frame interfered each other and the water stayed at this interfering section. It is presumed that the corrosion progressed little by little because this condition continued for a long time.

- In case the rust is only on the surface, the rust have to be completely removed and the touch-up painting must be carried out.
- In case the rust effects deep in the material or holes are found, repair by sectional cutting or the replacement of cradle is necessary.
