During operation of engine room crane, a trouble of hoisting motor suddenly happened and hoisting up and down became inoperative.

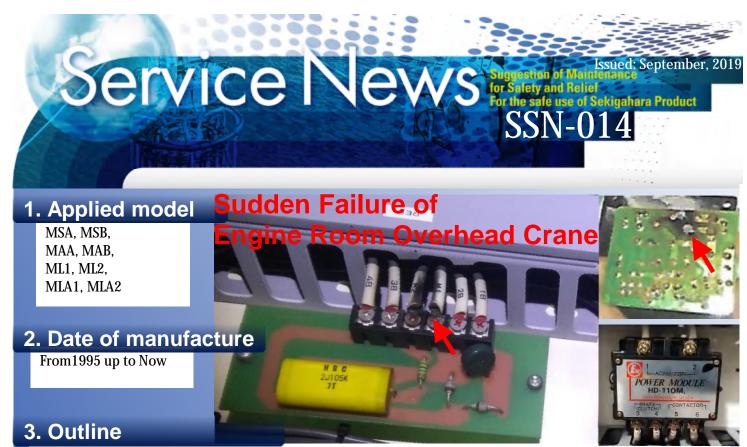
Upon detailed inspection of inside of the starter, it seemed that the part of the PCB (rectifier) was damaged.

Fuses repeatedly blew even if they were changed to new ones.

Due to the failure of magnetic brake or PCB (rectifier), the entire electric circuit to the maganetic brake caused an abnormality and the fuse which is a circuit protection parts was damaged.

For avoiding malfunction of magnetic brake, adjust the brake gap by following the handling manual. A Renewal of PCB (rectifier) is the only method for repair. Please be careful as this kind of troubles cannot be repaired even temporarily without this part. PCB (Rectifier, Power module, Power unit) is a printed circuit board that converts AC voltage into DC voltage. If an abnormality occurs only in a specific motor, check if the PCB is not burnt and the input and output voltages are normal.
