[SUBJECT] Fall of lifeboat caused by corrosion of hanging part for floating block

Precaution Information

1. Applied model

SHS-38-079, SHS-37-062, SHS-35-054,
SHS-36-062, SHS-34-056, SHS-34-046,
SHS-33-056, SHS-32-048

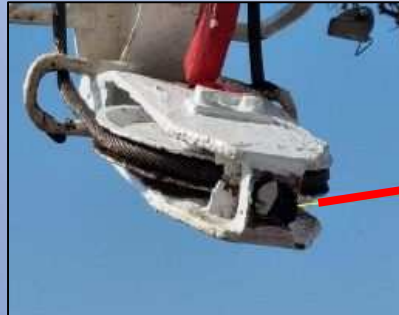
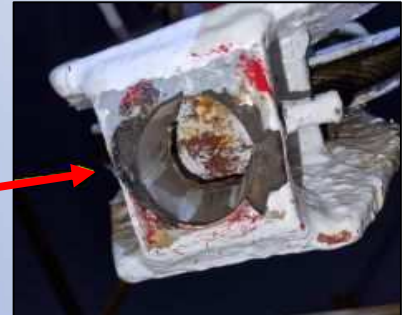
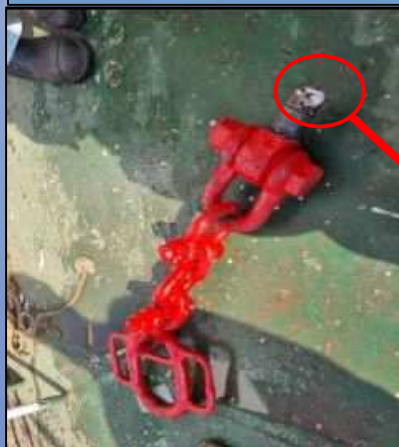
Chart 1

At annual inspection, the bottom part of the floating block fell off. Overlapped connecting section decreased due to corrosion of the outer diameter of the nut and it slipped out with the bush in the boss.

1. Corrosion by rain and sea water
2. This floating block has construction that a bush is pushed into inside of the boss. Corroded thin nut slipped out together with the bush (outer dia 42).

*Width across flats ("a" in Chart 1), thickness of side plate.

● Check the corrosion of nut and side plate

*If the material is corroded or worn out more than 10% of original size, it is recommended to renew. Evaluation is necessary for the main material excluding thickness of paint and corrosion.

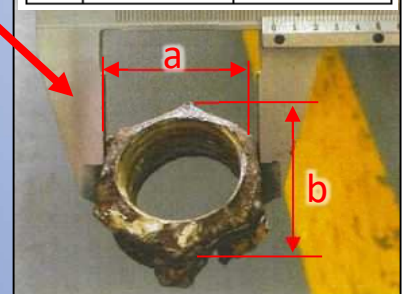
Reference

*This reference indicates the construction of bush.
(SHS-●●-○○○)
Other models are construction with no bush. Size of nut and hole differs depending on davit model.
