# Service News

## SSN-018

[SUBJECT] Coupling spider broken in pieces

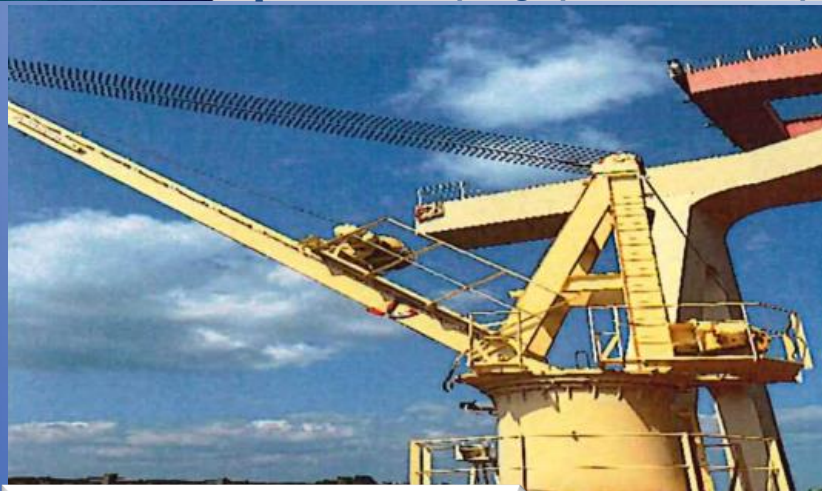
When the motor was removed for changing O-ring to repair grease leak from hoisting winch, it was found that the spider for the coupling was broken into pieces.

🔧 Seals used for this type of reduction gears, it is recommended to renew every 5 years. Additionally, it is also recommended to renew spiders for coupling every 5 years.

⚠ When you find abnormal sound during operation or slippery of the winch, stop using the crane immediately.

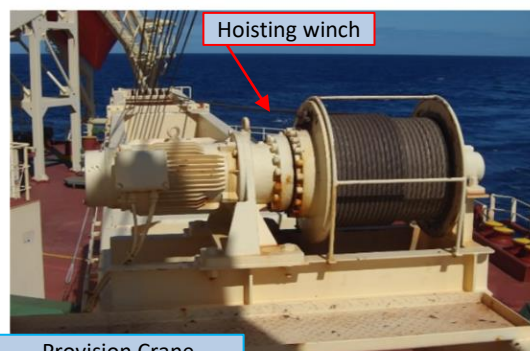
Hoisting winch

Provision Crane

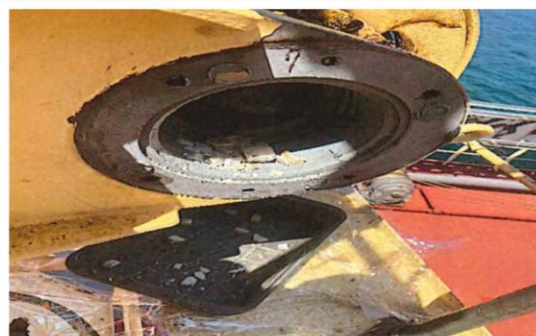
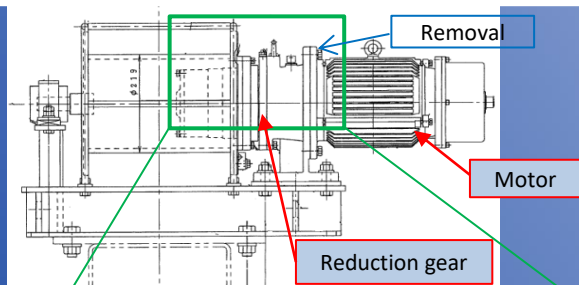
Removal

Motor

Reduction gear

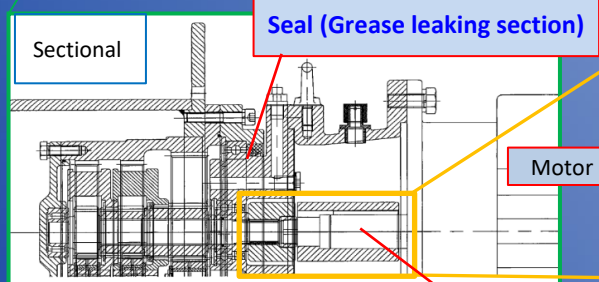
Sectional

Seal (Grease leaking section)

Motor

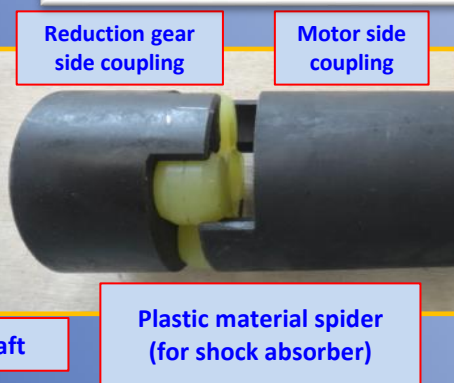
Reduction gear  
side coupling

Motor side  
coupling

Plastic material spider  
(for shock absorber)

Motor output shaft
