Service News

SSN-020

[SUBJECT] Drop of Traversing Motor on Engine Room Crane

Engine Room Crane MSB-, MAB- model

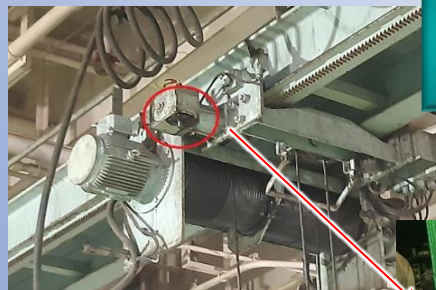
Accident Record

Drop of traversing motor caused by loosening of installation screw

For the crane with 17 years old, traversing motor dropped because of loosened screws which are used to install the motor to worm reduction gear.

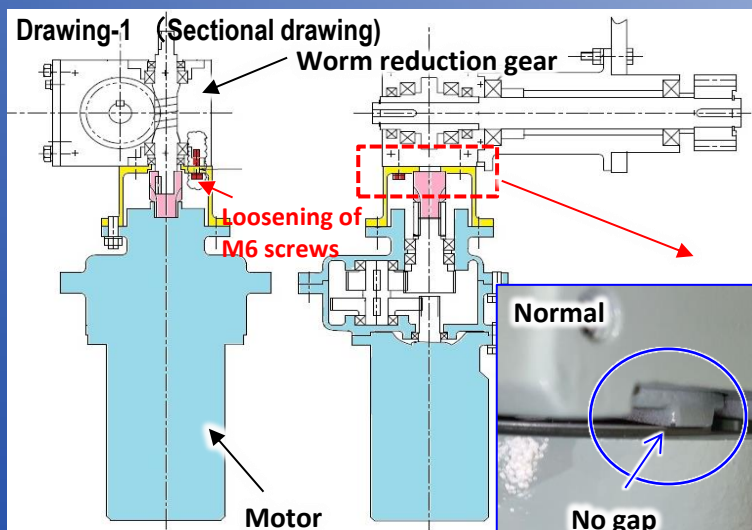
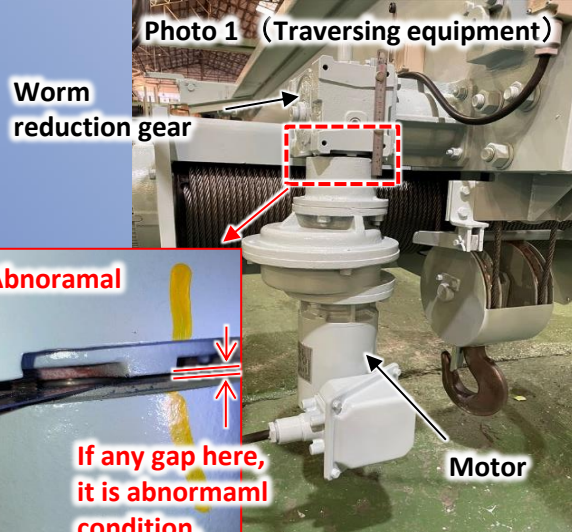
👉 When M6 screws (4 pcs) in Drawing-1 loosen and If gap appears between facing surfaces, the motor will swing.

Even if the crane is not used, at monthly inspection, check if the gap between facing surfaces and if there is no rattling at motor installing section.

In case worm reduction gear or motor is removed for maintenance or renewal, apply high strength type thread locking (such as LOCTITE263) on M6 screws in Drawing -1 For other items of inspection, refer "Regular Maintenance and Recommended Spare Parts List" in crane handling manual.
