# Service News

## SSN-021

### Accident Record

MSA\*\*/ MSB\*\* /MAA\*\*/ MAB\*\*

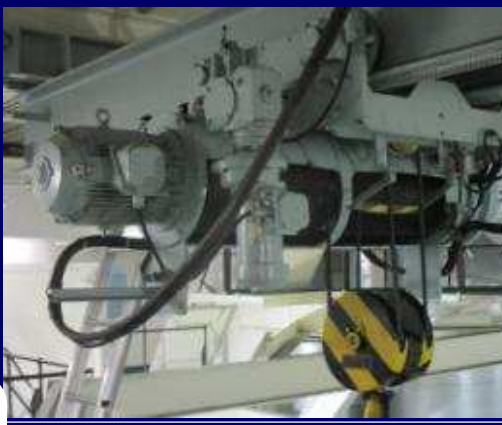
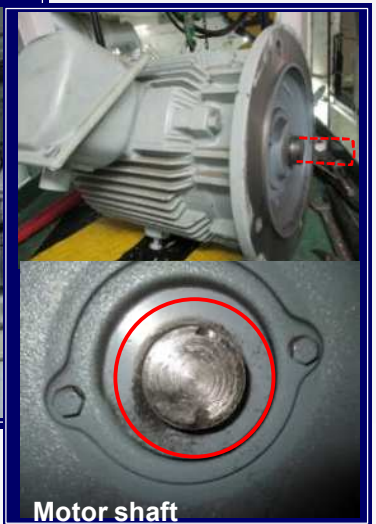
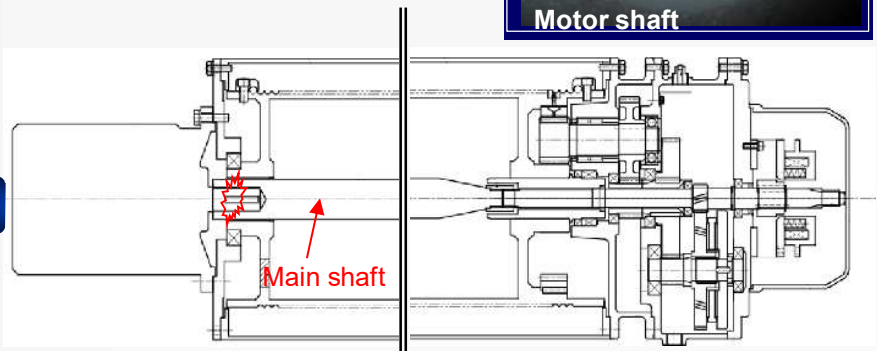
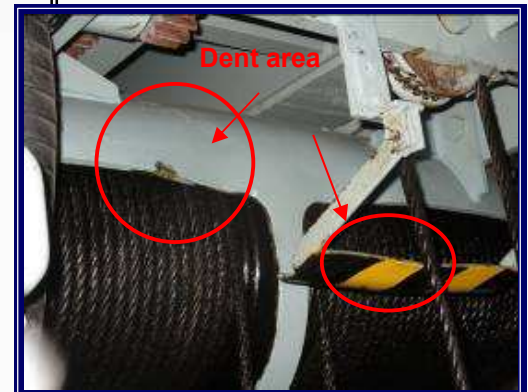
When hoisting up a spare exhaust valve for replcing by No.1 Engine Room Crane, there was metal-biting noise from the hoisitng motor and the motor was spinning freely. The brake was functioning with normal condition.

While lifting the spare exhausd valve from the base, the hook block bypassed the limit switch and struck the drum casing. This caused rotational wobble on the hoisting motor and the main shaft. Continuous

In case the crane operated for more than 800 hours, it is recommended replacing the hoisting motor and main shaft and overhauling. In case hitting damages are found on the drum casing, or abnormal noises or motor tripping still continue even after replacing the parts to new ones, the entire hoisting unit must be replaced.

- Check if the limit switch functions properly. Renewal is recommended every 10 years.
- Be careful not to lift diagonally when the hook is near the upper limit.
- If hitting damage or dents are found around the center of the drum casing, please contact an authorised service company.
- For aged products, it is recommended having an inspection by an engineer authorised by the maker.
