# Service News

## SSN-019

[SUBJECT] Crack Damage of Provision Crane Winch Drum

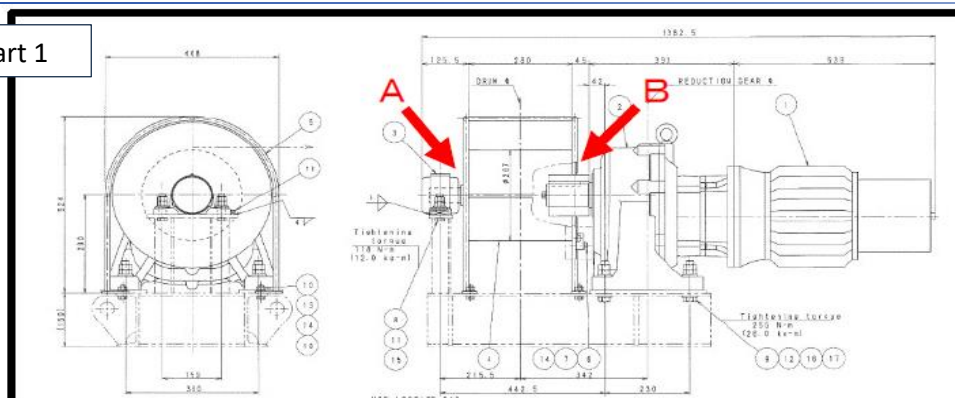
Chart 1

From 2008 ~ (Reduction gears in old model, Refer Chart 1)
