Suggestion of Maintenance for Safety and Relief For the safe use of Sekigahara Product

[SUBJECT] Preventing the Deformation of Brake Arm

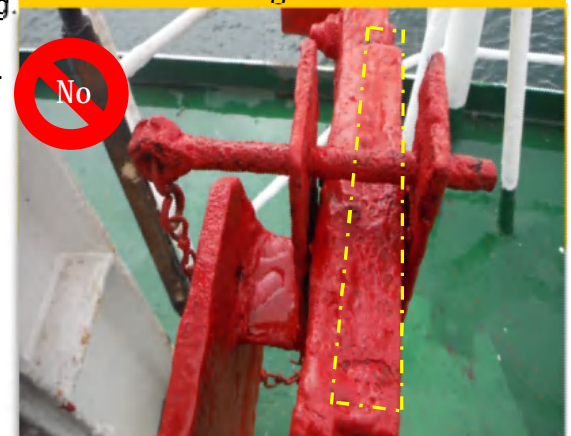
Lever is interfering with the guide because reinforcing material is too thick.

If the arm is worn out and becomes thin, repair work is necessary. Do not thicken the lever which may interfere with the lever guide.
