[SUBJECT] Fall of lifeboat caused by corrosion of hanging part for floating block

Precaution Information

1. Applied model

SHS-38-079, SHS-37-062, SHS-35-054,
SHS-36-062, SHS-34-056, SHS-34-046,
SHS-33-056, SHS-32-048

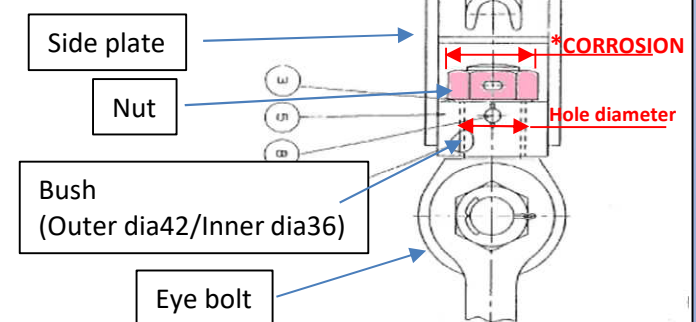
Reference

1. Corrosion by rain and sea water
2. This floating block has construction that a bush is pushed into inside of the boss. Corroded thin nut slipped out together with the bush (outer dia 42).

*This reference indicates the construction of bush.
(SHS-●●-○○○)
Other models are construction with no bush. Size of nut and hole differs depending on davit model.

● Check the corrosion of nut and side plate

*If the material is corroded or worn out more than 10% of original size, it is recommended to renew. Evaluation is necessary for the main material excluding thickness of paint and corrosion.

*Width across flats ("a" in Chart 1), thickness of side plate.
